# Vitreous Enamel Coating Surface Defects and Evaluation of the Causes

**Abstract:** Enamel is composed of oxide forms, applied on a metal substrate with a firing temperature range of 800-870°C. Vitreous enamel coatings play a very important role in the coating production process of steel in accordance with the technical and aesthetic properties. Surface quality of the enamel coating can be affected by various defects. In this study, most common enamel surface defects obtained during laboratory trials have been investigated and elimination actions have been discussed.

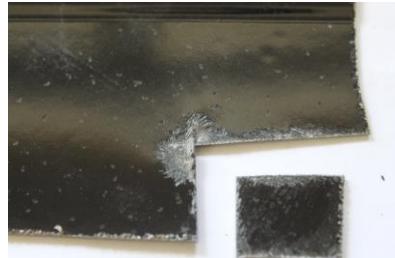
Sample with fish scale (Fig. 2) has been examined via SEM analysis. Small piece was cut for cross-sectional examination. Chemical composition of the defect-free and defective areas were compared (Table III). SEM image for these areas is shown in Fig. 3.

Fig. 2 Sample with fish scales defect

Main reason for fish scale is hydrogen diffusion through the steel and into the enamel layer. As seen from the EDS elemental analysis, defect-free and defective points almost have the same chemical content. That proves visual inspection comment was correct. Defect was not caused by an impurity but hydrogen presence due to insufficient drying. In the trials to come, as a preventive action, substrates were dried for 10 minutes after surface cleaning step, defect had been eliminated.

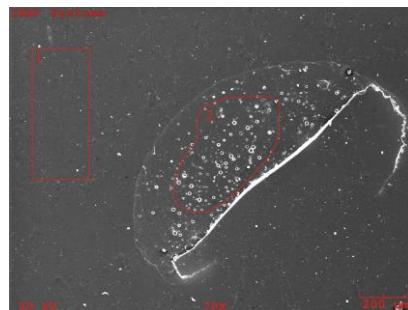
Fig. 3 Scanning electron micrograph of fish scales defect

EDS ANALYSIS OF DEFECT-FREE AND DEFECTIVE POINTS FOR FISH SCALE

Areas	O %	Na %	Al %	Si %	Cl %	K %	Ti %	Fe %	Zr %
Defect-free (1)	33,78	9,45	0,98	43,14	0,09	4,15	6,13	1,98	0,36
Defective (2)	35,72	8,18	0,78	41,99	0,06	5,23	4,46	3,21	0,20

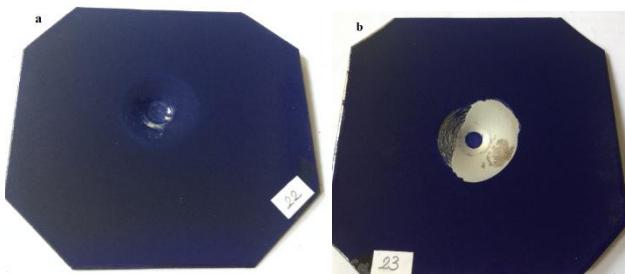
In some cases, poor adhesion was observed after impact tests. Samples showing good adhesion (Fig.4a) and poor adhesion (Fig.4b) were compared via SEM cross sectional analysis (Fig. 5a and 5b) to understand the failure cause.

Fig. 4 Impact test results of samples showing a) good adhesion, b) poor adhesion

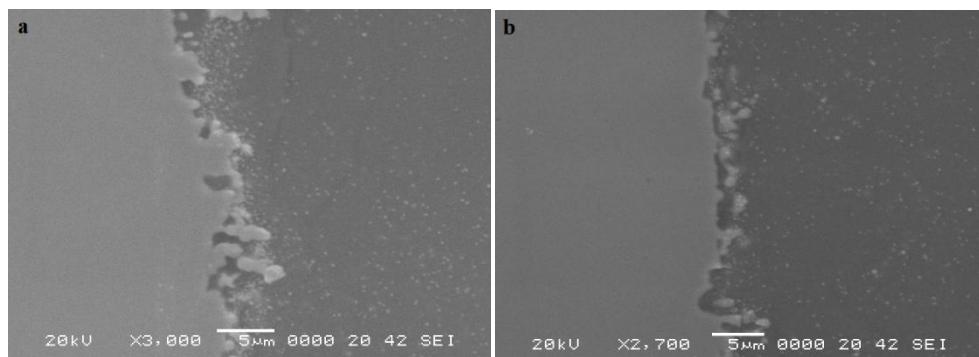
Fig. 5 SEM Cross sectional examination of poor adhesion defect, a) good adhesion, b) poor adhesion

Adhesion can be both mechanical and chemical. Mechanical side is achieved by dendrites along the enamel-steel interface. In Fig.5, two different interfaces from two different samples were shown. Both samples were prepared with the same enamel powder, in the same thickness and fired at 840°C. Firing duration was 6 minutes in Sample b where it was 4 minutes in Sample a. As seen from the micrograph, as duration increases, dendrite formation started to break away from interface. Due to loss of interlocking, after an optimum firing duration, adhesion gets worse. In the trials to come, as preventive actions, optimum firing parameters were set and substrate was changed to a different chemical composition with lower C content, from EK to ED. By using ED, outgassing during firing is reduced and surface quality of the final product was promoted.

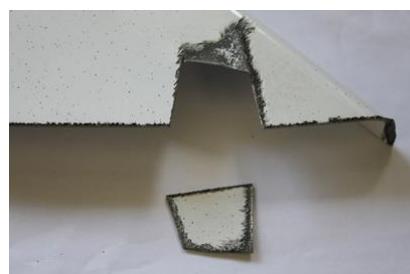
Especially in white enameled samples, blisters were visually detected at the surface (Fig.6). Sample was prepared for elemental analysis with EDS SEM to determine whether local gas development or impurities were the main reason for these formations.

Fig. 6 Sample with blisters defect

From EDS elemental analysis results, it was clearly stated from the increment in Cl content that, blisters were formed due to the residues of alkali surface cleaners which were utilized in substrate preparation stage to clean rolling oil. With addition of an extra rinsing step with distilled water to substrate preparation stage, blisters had eliminated in the trials to come.

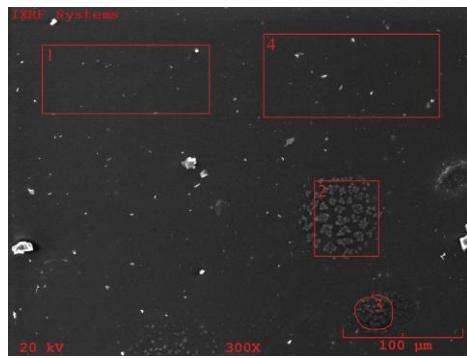
Fig. 7 Scanning electron micrograph of blisters defect

Both defect-free and defective areas were examined via EDS SEM analysis. Area 1 and 4 were defect-free areas. In Area 2 and 3 blisters were detected. Chemical analysis results were shown in Table IV.

TABLE IV  
 EDS ANALYSIS OF DEFECT-FREE AND DEFECTIVE POINTS FOR BLISTERS

Areas	O %	Na %	Al %	Si %	Cl %	K %	Ti %	Zr %
Defect-free (1)	36,27	7,42	1,24	29,64	0,13	7,81	14,85	2,64
Defect-free (4)	34,17	8,35	1,16	29,97	0,092	7,72	15,85	2,68
Defective (2)	33,83	10,25	1,57	17,59	15,16	5,62	13,24	2,74
Defective (3)	26,02	13,83	1,51	19,27	16,81	10,62	9,18	2,76

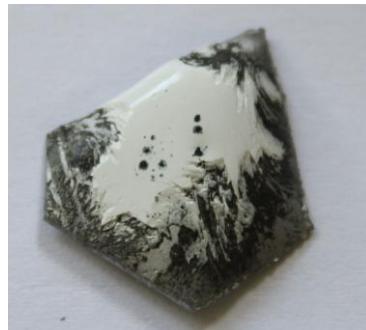
Sample with impurity defect (Fig.8) was examined via SEM analysis. Defect-free and defective areas, shown in Fig.9, were compared to understand the cause in Table V.

Fig. 8 Sample with impurity defect

EDS analysis showed that, an increment in Ca, Na and Fe contents was determined. Ca and Na increment was caused by alkali residues from substrate preparation stage. The change in Fe content was significantly noticeable. Due to surface discontinuities caused by alkali residues, enamel coating was not applied homogeneously. After firing, Fe content from steel substrate had come up beneath coating and caused this sudden increase. With utilization of a rinsing chemical in substrate preparation stage, defects caused by impurities had been eliminated.

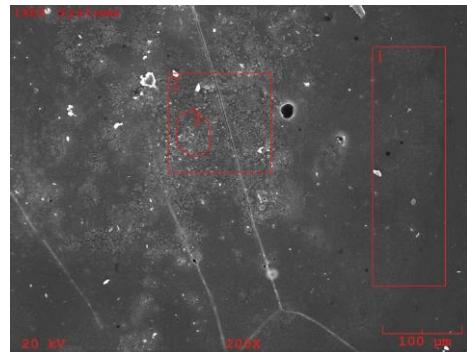
Fig. 9 Scanning Electron Micrograph of impurity defect

TABLE V  
 EDS ANALYSIS OF DEFECT-FREE AND DEFECTIVE POINTS FOR IMPURITIES

Areas	O %	Na %	Al %	Si %	Cl %	K %	Ti %	Zr %	Fe %	Ca %	Cr %
Defect-free (1)	23,65	7,13	1,28	31,90	0,11	10,39	14,85	2,64	2,39	5,36	0,30
Defective (3)	9,73	10,85	0,72	12,07	0,41	2,34	3,70	2,79	42,31	14,92	0,16
