Analysis of Aircraft Wheel Hub Assembly Using NDT Techniques

Keywords: Wheel hub assembly, Fatigue crack, Non-Destructive testing.

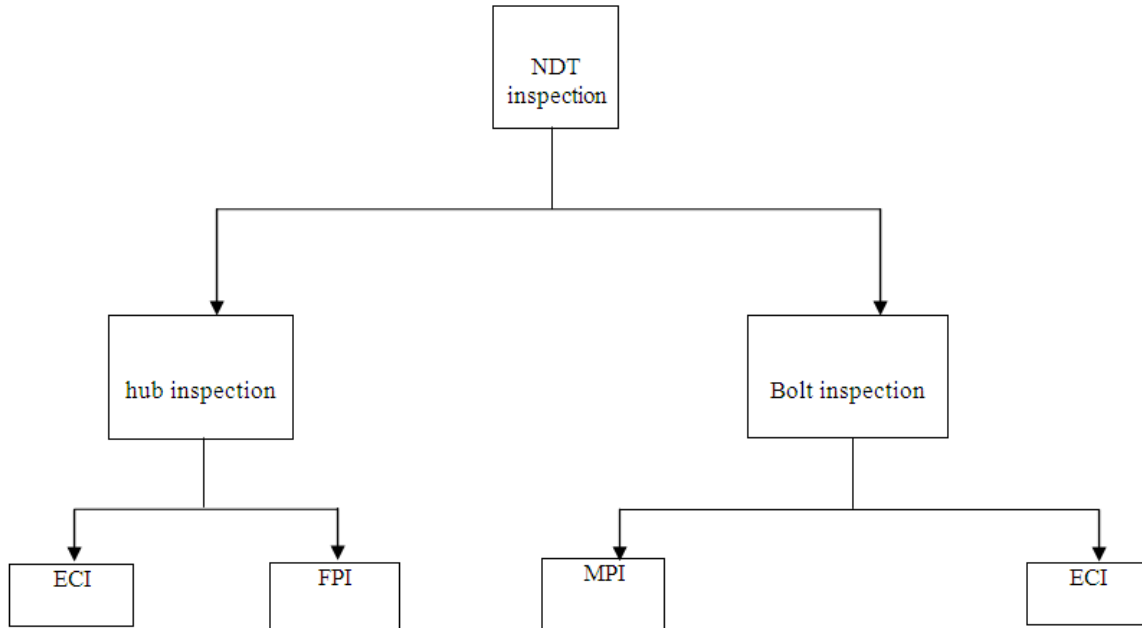
Figure: 1. Flowchart showing NDT methods in workshop

NDT inspection of aircraft wheel hub during routine check-up involves the inspection of aircraft wheel hub and its components. NDT inspection of the aircraft wheel hub inspection is shown in the flow chart figure 1.

Aircraft wheel hub can be inspected using eddy current inspection and liquid penetrant inspection. Tie bolts is inspected using magnetic particle inspection. Visual inspection is used to check the bearing, O ring, heat shields etc. First the wheel arrives at the maintenance workshop with the unserviceable tag. A visual inspection of the wheel hub assembly is carried out to know the condition of the wheel hub assembly. Then the wheel hub assembly is disassembled and the wheel hubs along with the other parts are sending for cleaning. After cleaning the wheel hubs and other parts are inspected using NDT methods.

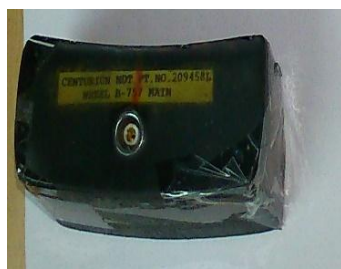
Figure: 2. Bead seat probe

For the inspection of bead seat area special probes can be used. Figure 2 shows a bead seat probe used for eddy current inspection.

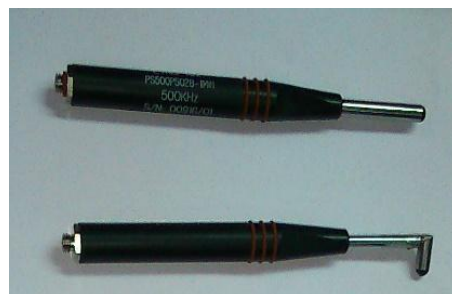
Figure: 3. Pencil probes

The mating regions of the wheel is inspected for any indications of cracks or initialization of corrosion. Pencil probes Figure: 3 are used to inspect the mating surfaces of the hubs. Inspection is carried out as per the NDTM manual. Region around the bolt holes is also inspected for any defects. Figure 4 shows the inspection around the bolt holes. Region around the bolt hole section have a chance to develop the crack. The bolt hole region is also inspected for any signs of crack.

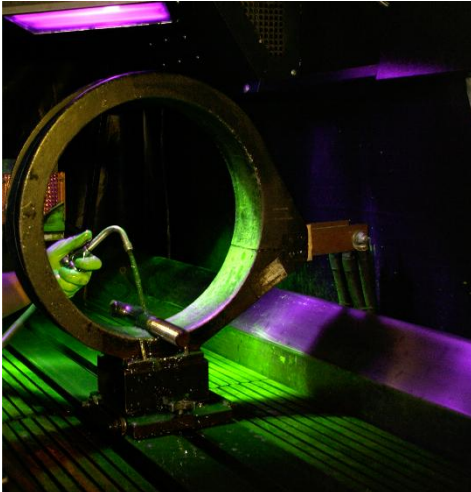
Figure: 5. Magnetic particle inspection

MPI is conducted on the Tie bolts of the wheel hub. The bolt with a crack or corrosion in the shank, radius or thread is rejected. MPI of the Tie bolts is done as per the manual and can be done only on ferrous materials. In this method the bolts are kept in the coil and magnetized. A bath (water containing magnetic particles) is introduced. Figure 5 describes the short coil experimental set up for the MPI. In this method the bolt is placed inside the circular coil and magnetized. The longitudinal magnetization of the bolt is done. The region of inspection of tie bolt using MPI is the thread region. Thread region is inspected for any cracks and if any cracks exist, then the bolt is discarded. If a cracked tie bolt is used then it may lead to the failure of the bolt which also may lead to the failure of the wheel hub.
